01 PREVIOUS STATE

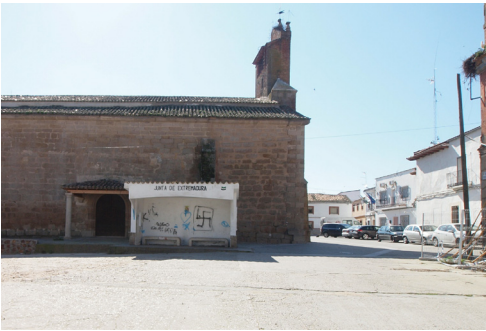
A_BUS STOP
THE OLD FASHIONED STRUCTURE, ALSO DEGRADED, BROKE THE HARMONY OF THE SQUARE

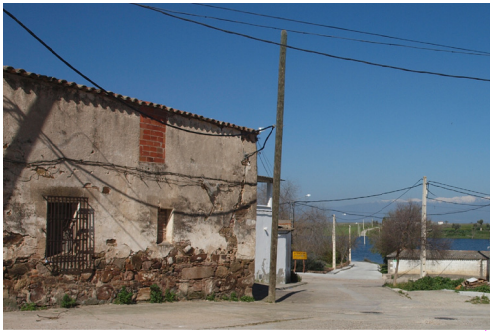
B_ELECTRICAL AND PHONE WIRINGS
A HIGH NUMBER OF WIRINGS THAT INTERFERED WITH THE PANORAMIC VIEWS TO THE LAKE AND THE MOUNTAINS

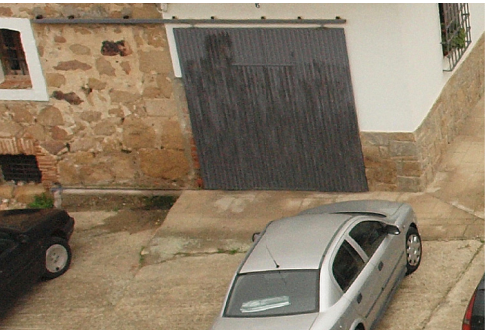
C_ILLEGAL RAMP AND GARAGE
AN ILEGAL RAMP BUILT TO ACCESS TO A PRIVATE AND ALSO ILEGAL GARAGE IN A PROTECTED BUILDING

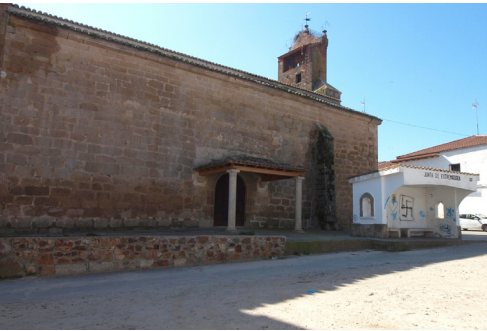
G_SLOPE NEAR THE CHURCH
THE REMAINS OF A FORMER LOADING DOCK FOR CATTLE COULD BE SEEN NEXT TO THE SLOPE CLOSE TO THE CHURCH, AS WELL AS A DEGRADED MASONRY WALL

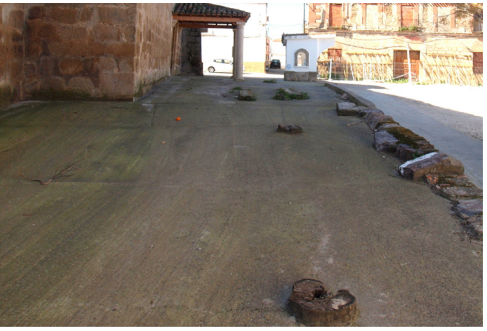
H_DEAD TREES
DEAD TREE TRUNKS, AND ALSO TWO MORE OLD TREES CLOSE TO BE DRIED, LAID IN SOME POINTS

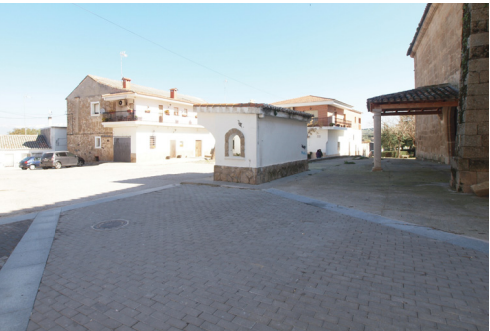
I_LINK WITH PLAZA CONSTITUCIÓN
THE SAME TYPE OF PAVEMENT ALREADY USED IN PLAZA CONSTITUCIÓN REDEVELOPMENT (2012), NEEDED TO BE CONTINUED

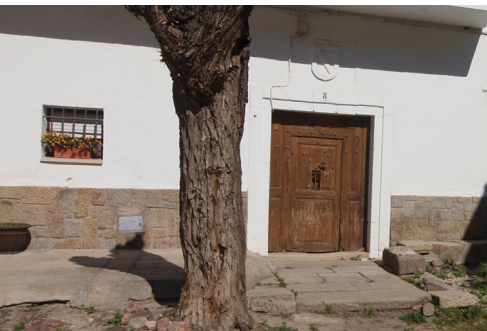
D_OLD SURFACE PARTIALLY COVERED
PARTS OF THE OLD GRANITE SURFACE NEAR THE NOBLE BUILDINGS ENTRANCE HAD BEEN COVERED

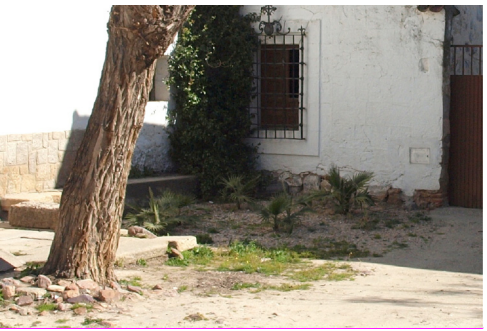
E_HUMIDITY
OCCASIONAL WATER ACCUMULATION IN A LOW POINT LED SMALL PALMS AND WEEDS GROWING IN ONE OF THE CORNERS

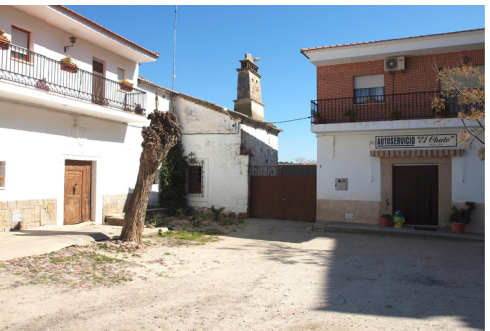
F_ILLEGAL PAVEMENTS
SOME NEIGHBORS BUILT ILLEGAL PAVEMENTS BREAKING THE SURFACE LEVEL OF THE SQUARE
