01. CHIADO PUBLIC SPACE . CARMO CONNECTION

Lisbon . Portugal . 2016

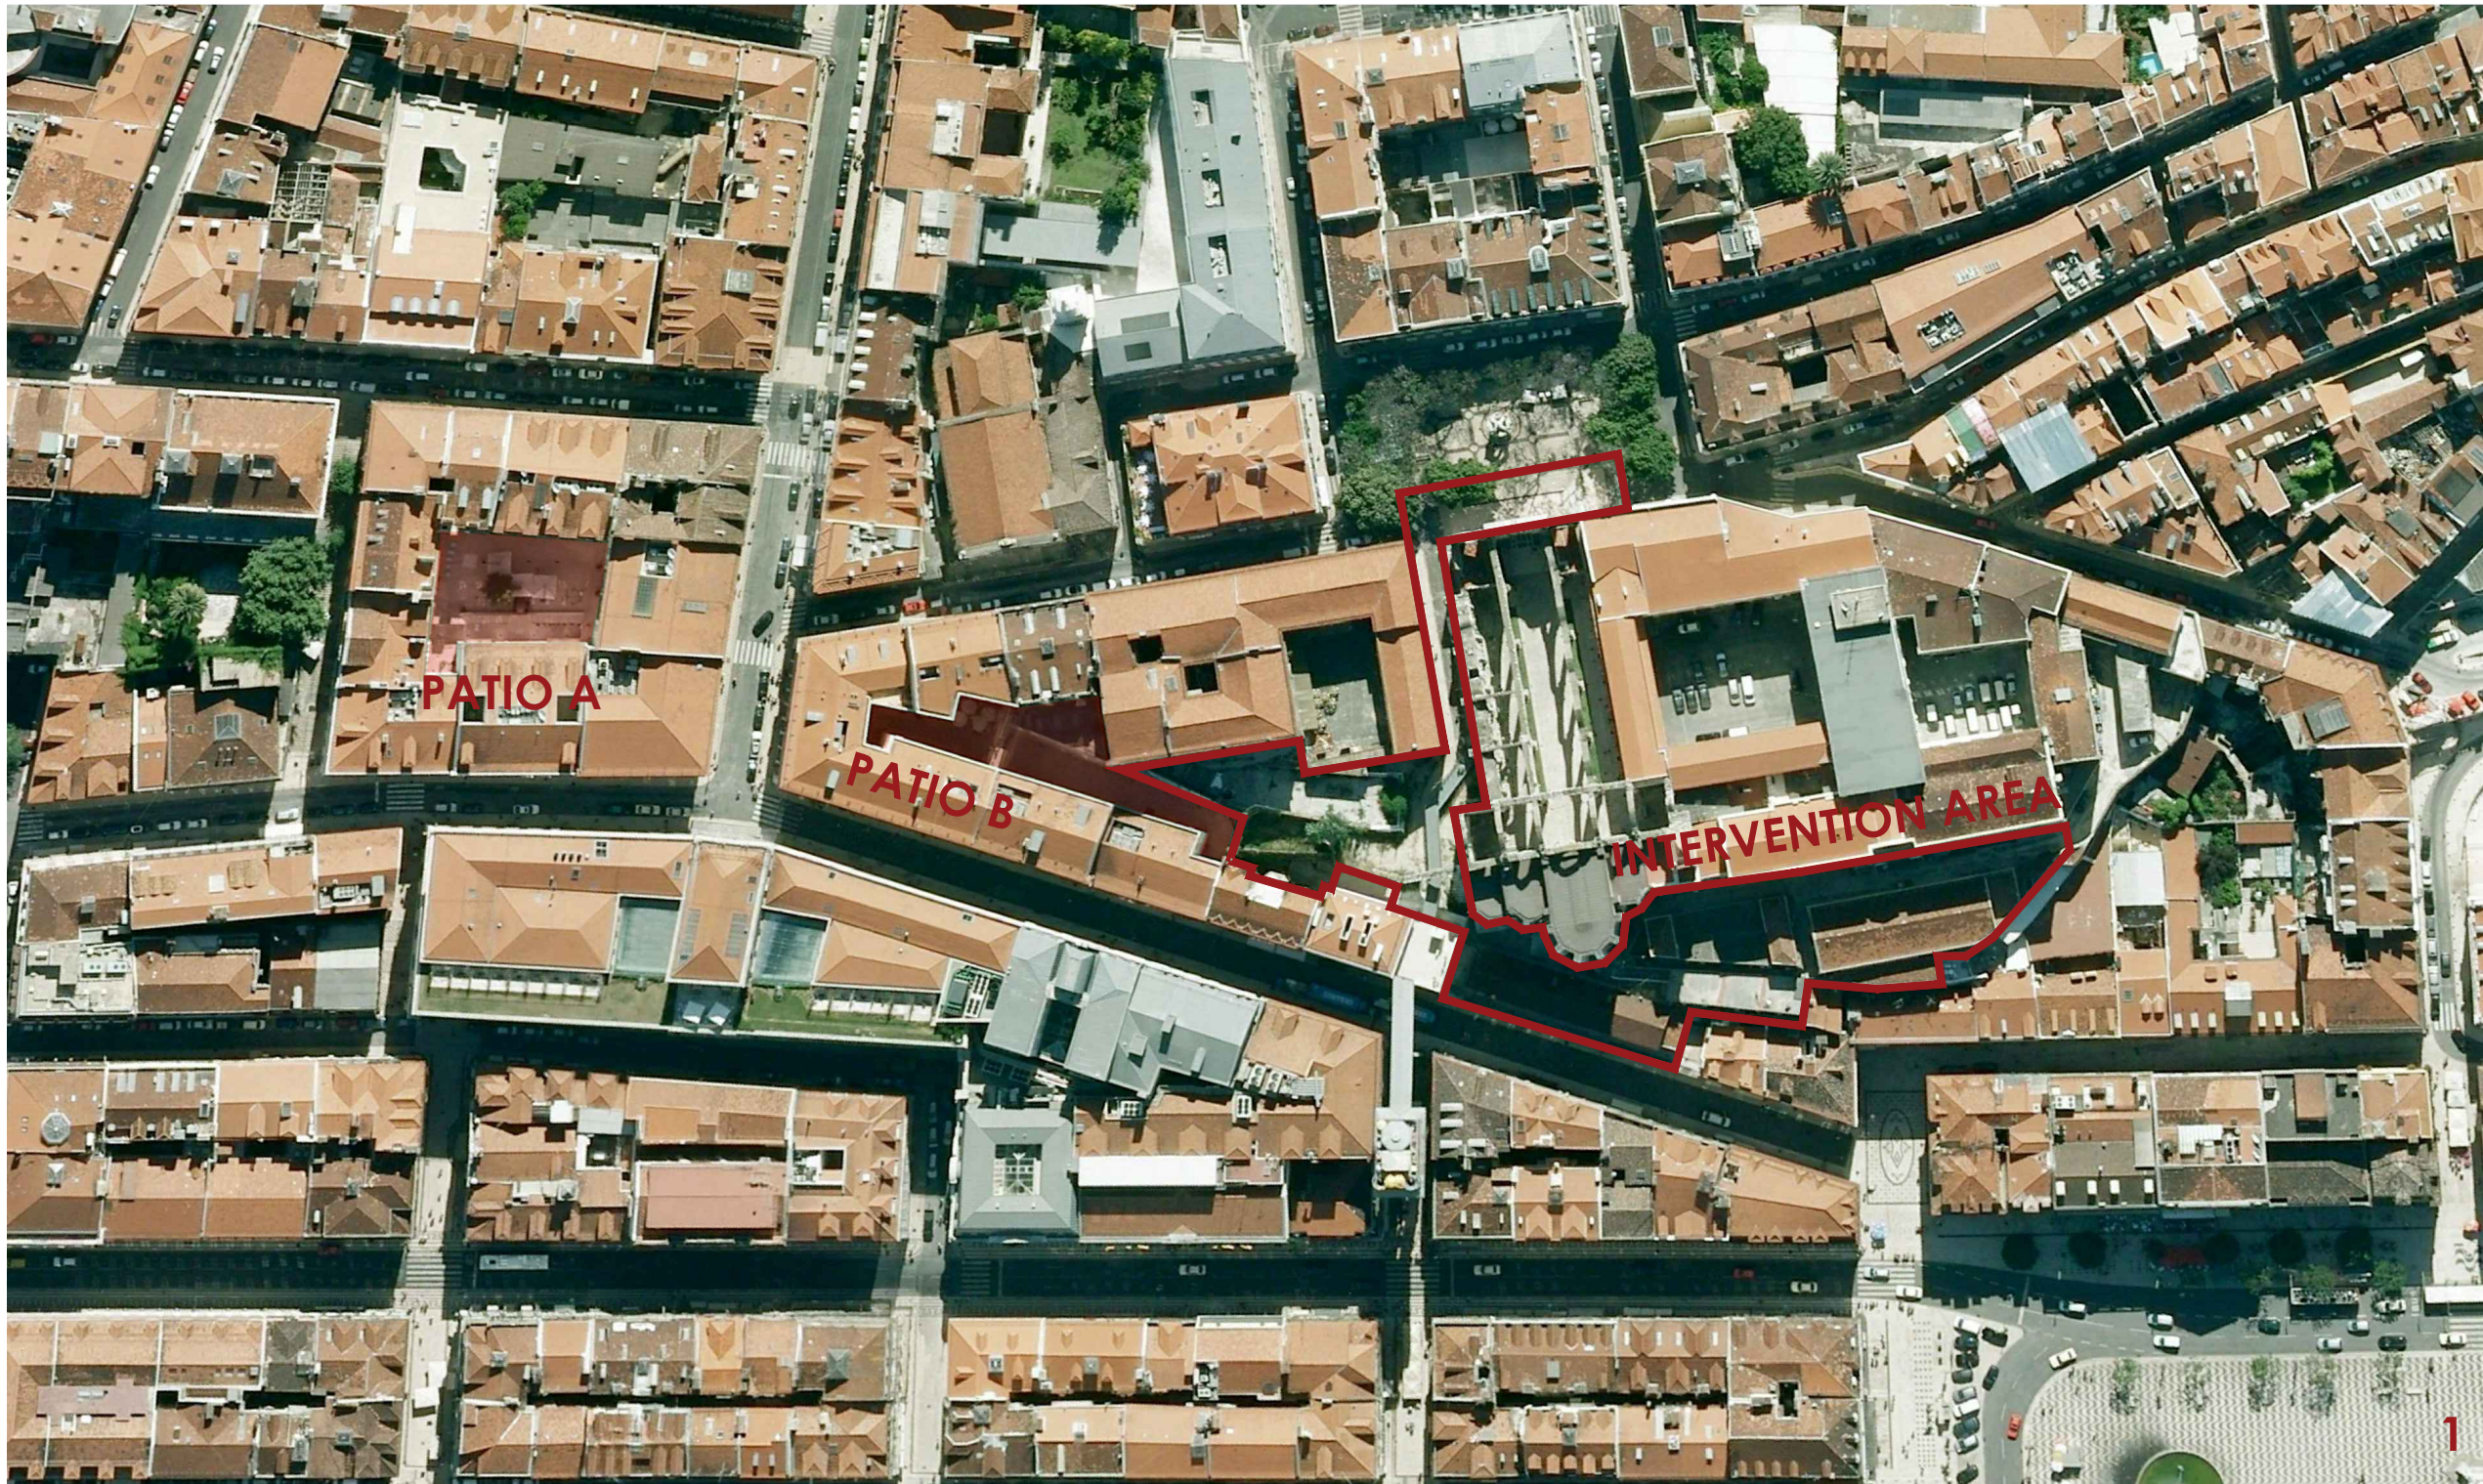
1. Aerial view of the existent. It shows the earlier intervention of Chiado reconstruction after the fire of 1988. The new intervention intends to complete the connection of Patio B with the ruins of the Church of Carmo, the Carmo Square and the Santa Justa Lift.

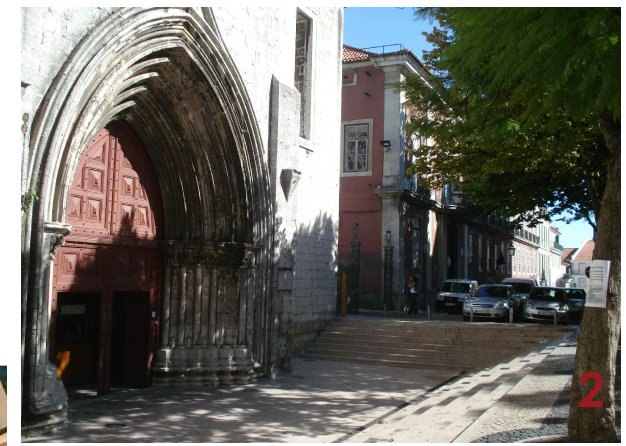
2. Carmo Square Convent entrance shows a change in the original street level and now the access is made by stairs. On lateral side, a gate to close the connection with the Santa Justa Lift and ground level of the church ruins.

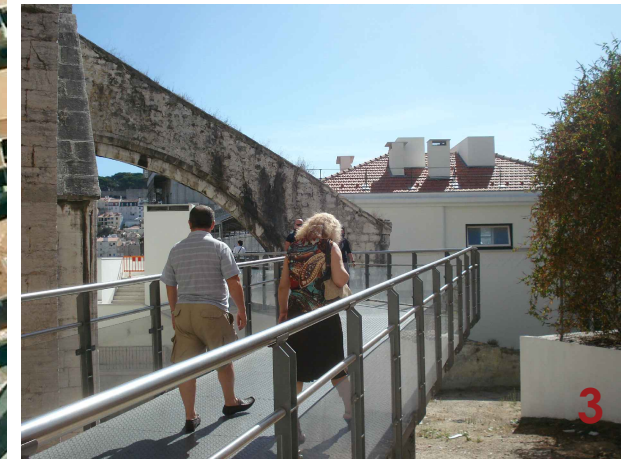
3. The existent state of the public space does not allow the permanency of public on the ground and the connection to Santa Justa Lift is done by a metallic bridge.

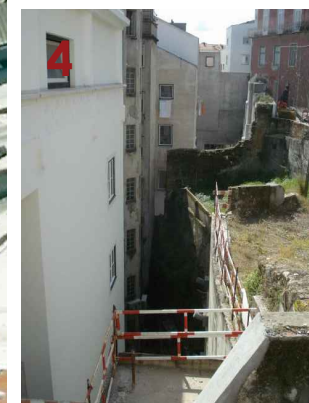
4. This view from the bridge shows the non-existent connection to Patio B.

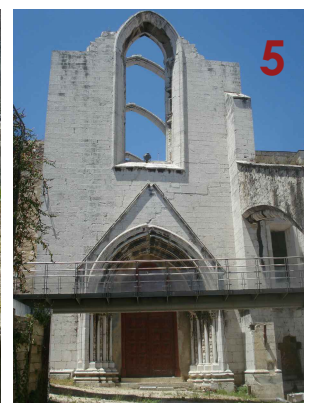
5. One of the most disturbing facts of the existent is the ground level of the Church. There is a complete miss caring of the area and the metallic bridge is a visual barrier that does not benefit the space of the ruins.

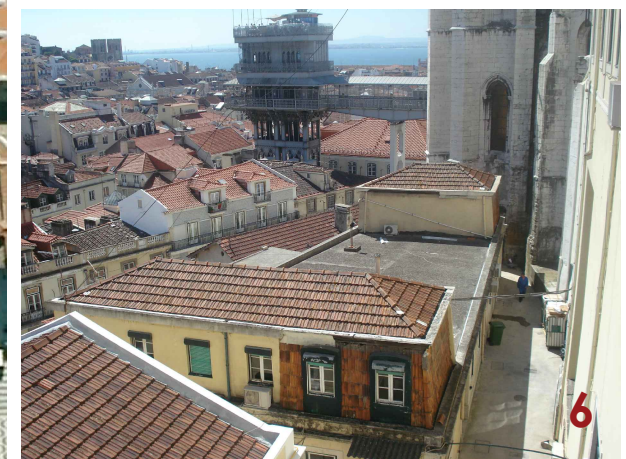
6. Over the years some buildings were built to fulfill the needs of the GNR Military Quarters. Today they no longer have this need so it is proposed to demolish some constructions and recover others.

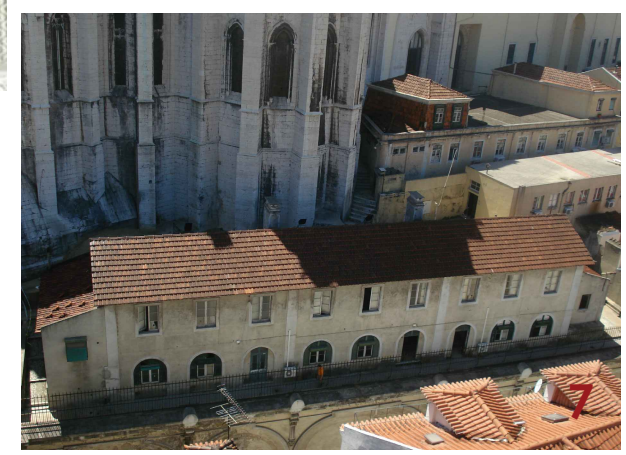
7. View from Santa Justa Lift over the existent buildings and future Carmo Terrace.
