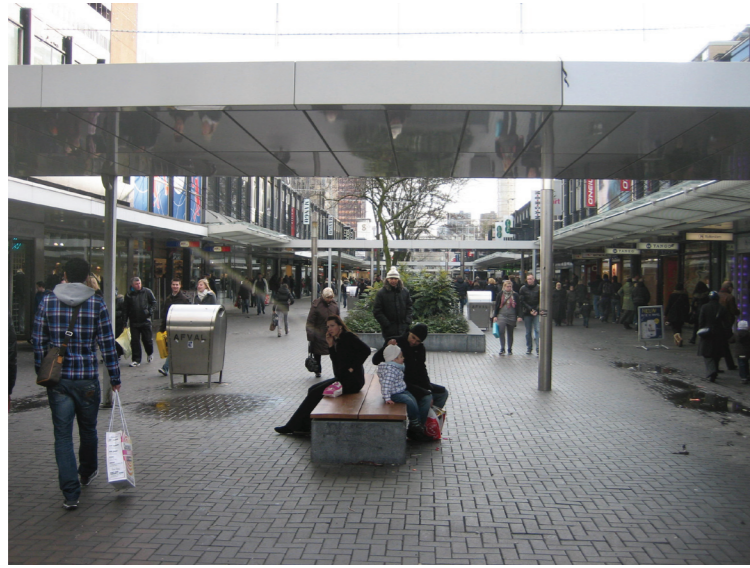
situation Lijnbaan before intervention:
streetfurniture is blocking the perspective on the architecture

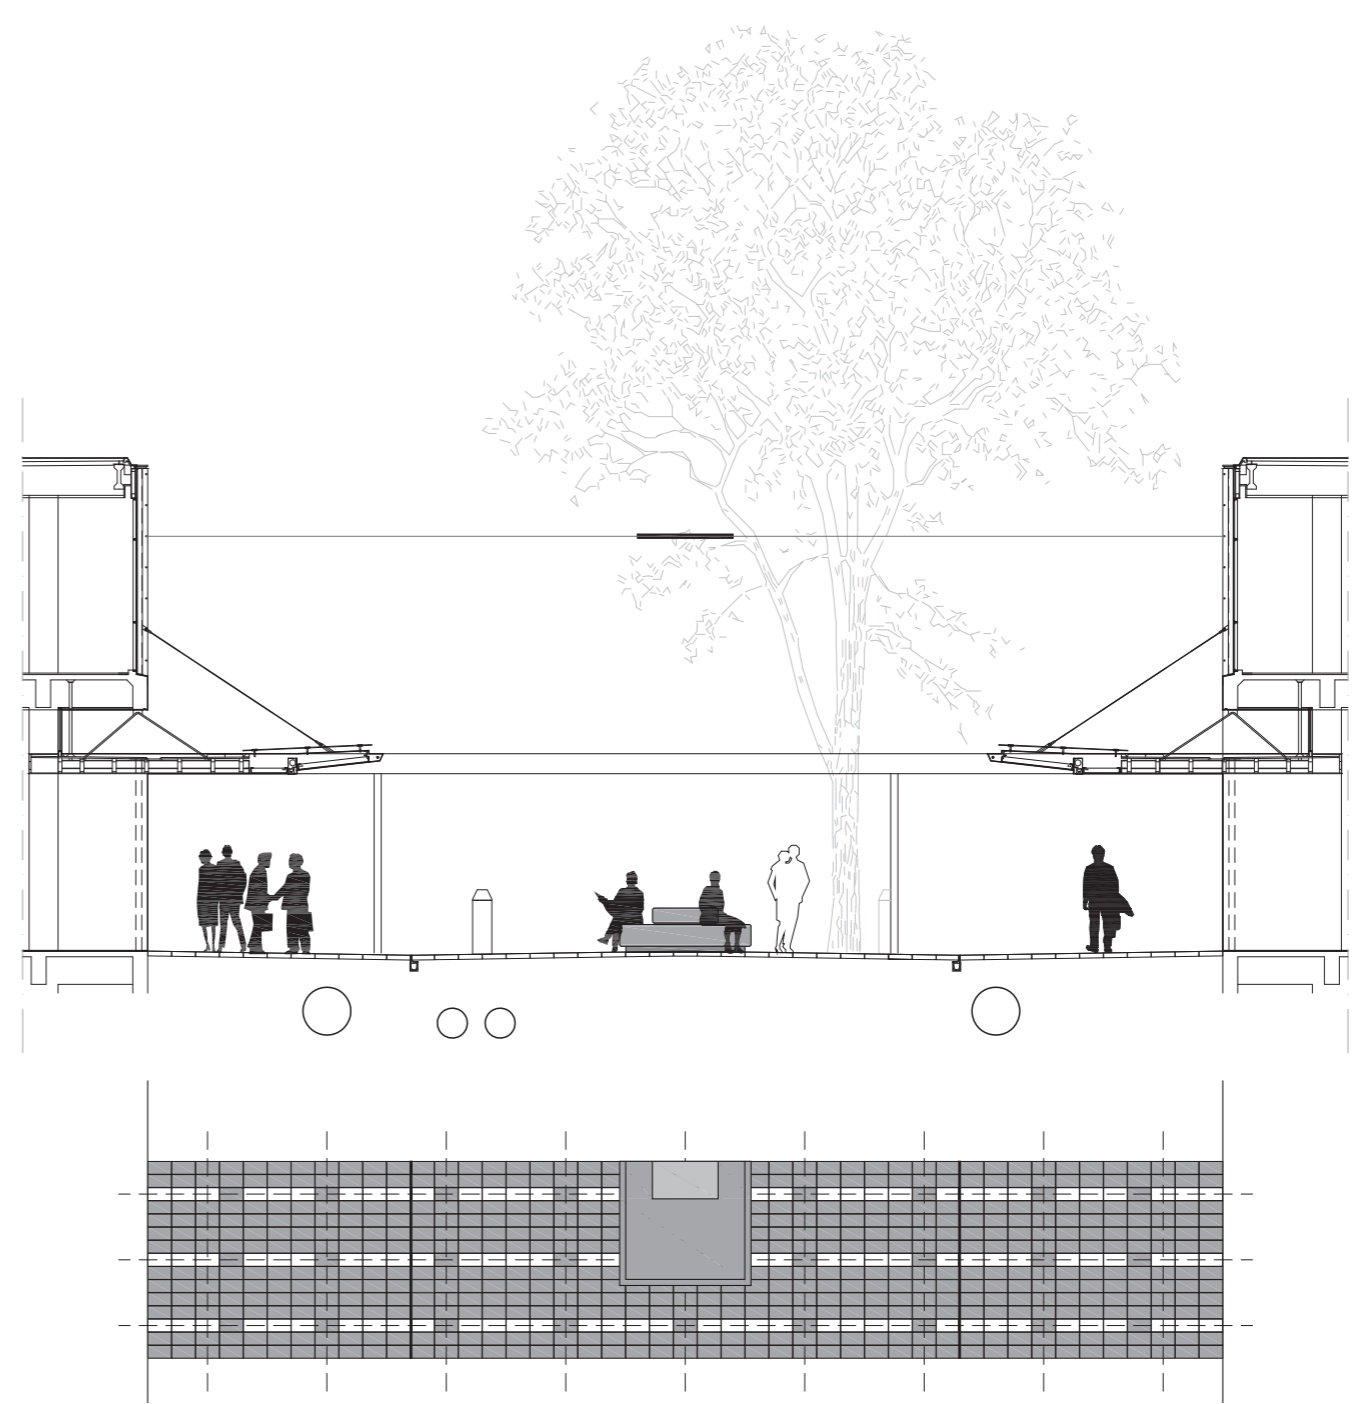
design drawing: cross section of the Lijnbaan with the new benches and lighting

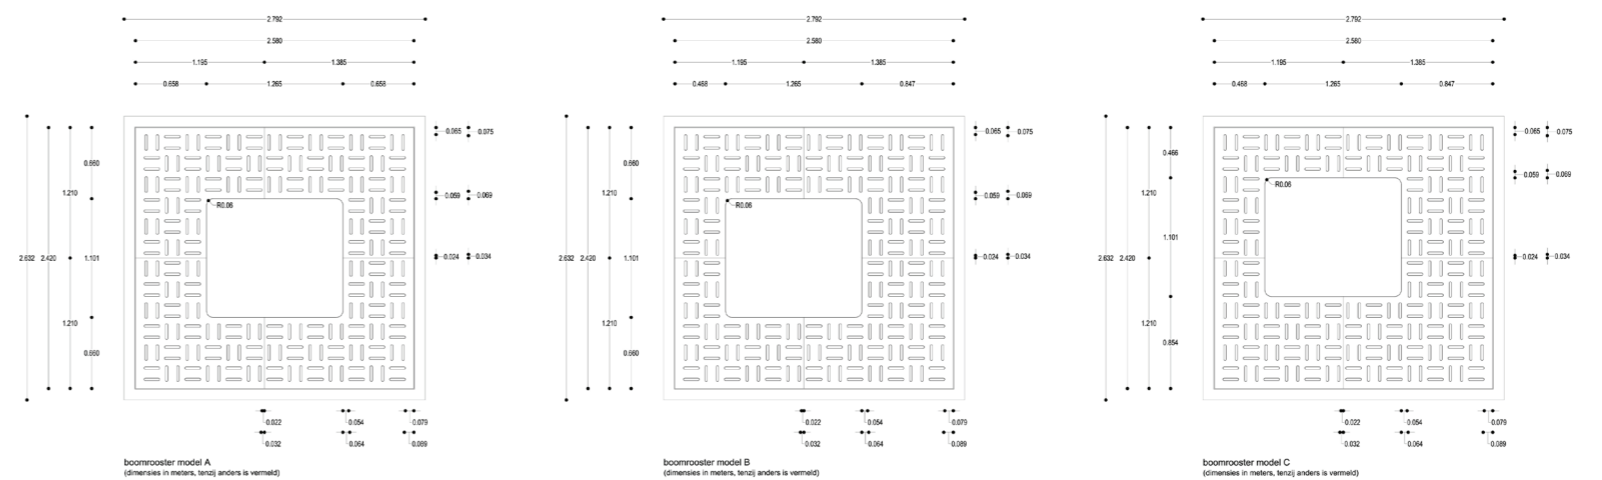
design drawing of the tree grates
