## REHABILITATION OF PLAZA DE LA LEÑA

## **K112\_2**/3

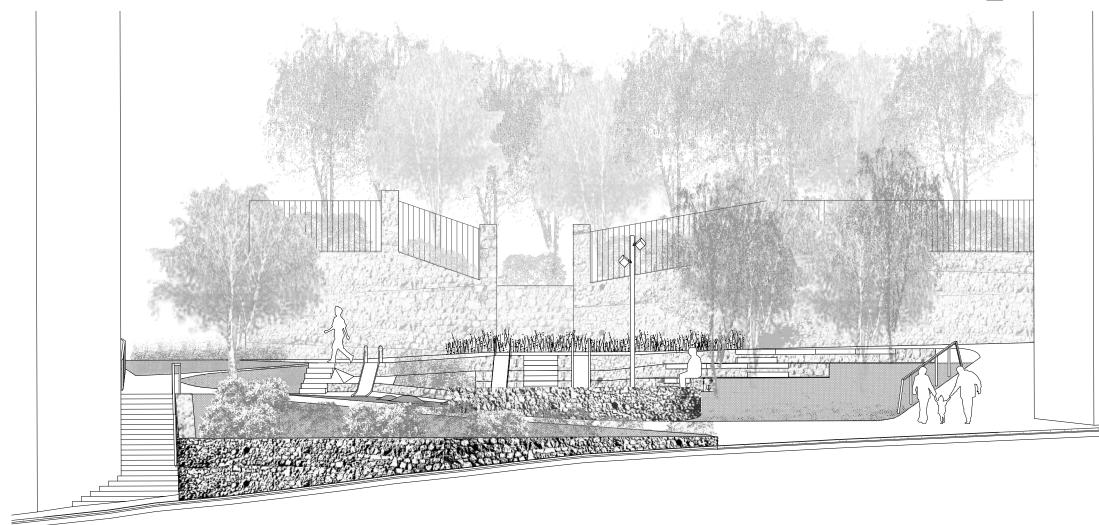
Under these lines, photos during the work. Above, section 1.
