# REHABILITATION OF PLAZA DE LA LEÑA

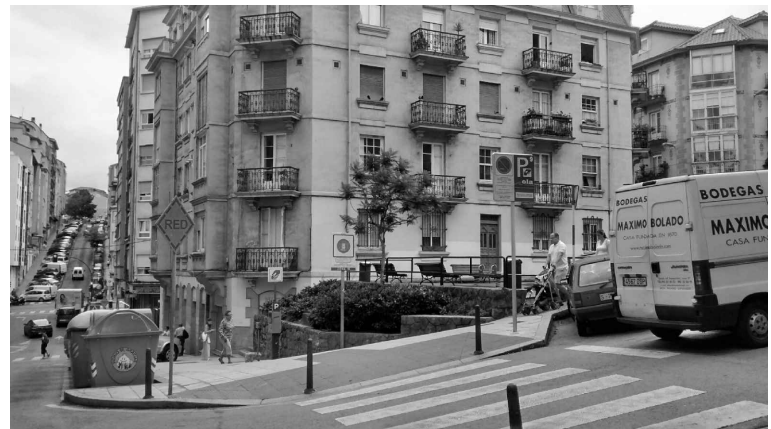
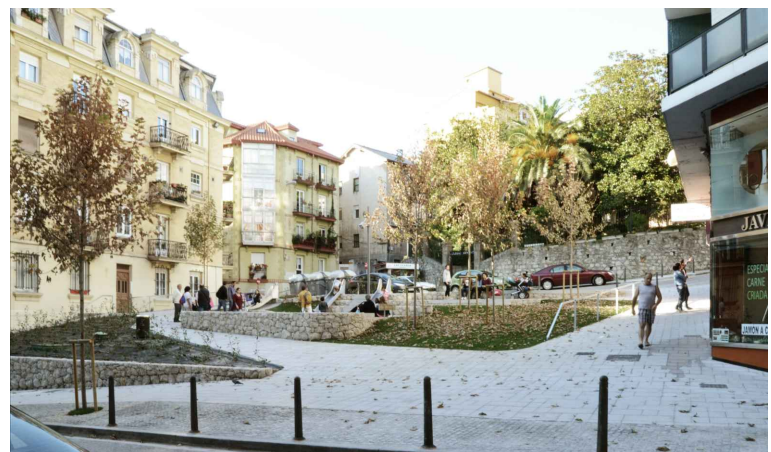
Under these lines, views of before and after works.
